Field Demonstration of Propane
Biosparging for *In Situ* Remediation
of N-Nitrosodimethylamine (NDMA) in Groundwater

ESTCP Project ER-200828

DECEMBER 2015

Paul B. Hatzinger, Ph.D.
David Lippincott, P.G.
CB&I Federal Services, LLC.

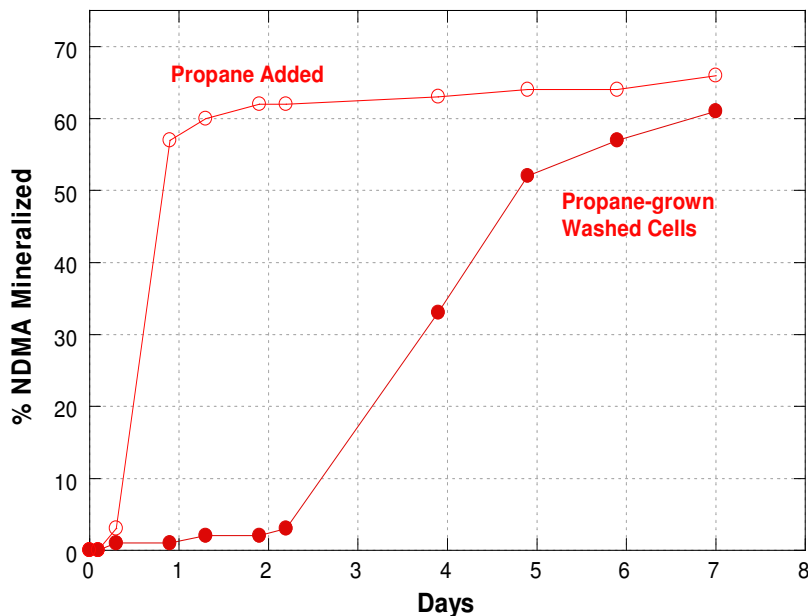
Figure 2-5. Effect of propane on the mineralization of ^{14}C -NDMA to $^{14}\text{CO}_2$ by the propanotroph *Rhodococcus ruber* ENV425. Propane added to the headspace of the reaction vessels stimulated NDMA mineralization rather than being inhibitory.

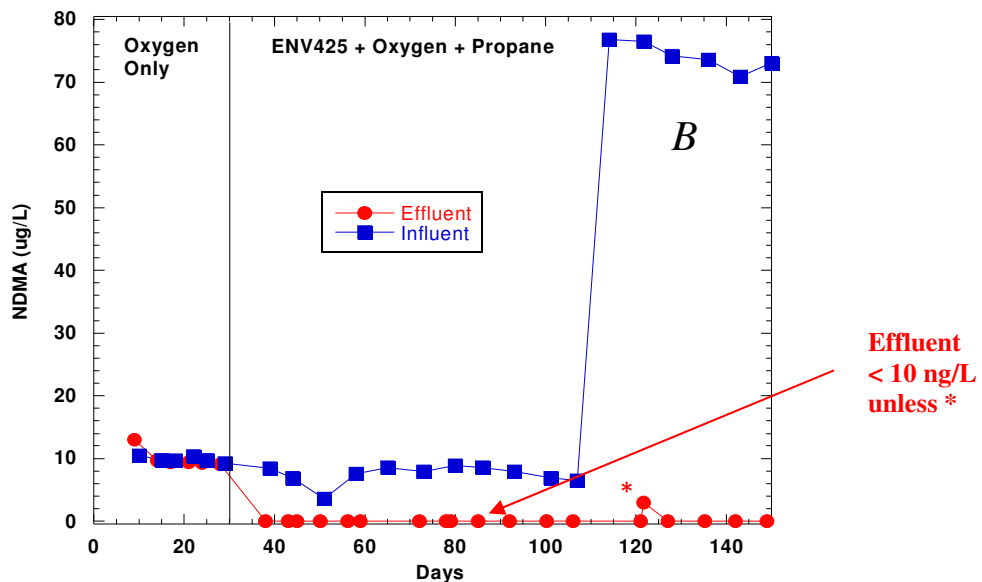
Figure 2-6. Laboratory propane-fed membrane bioreactor treating NDMA (Panel A). Influent and effluent data from the MBR (Panel B). All effluent points after culture inoculation were < 10 ng/L except that denoted with a *. Modified from Hatzinger et al., (2011).

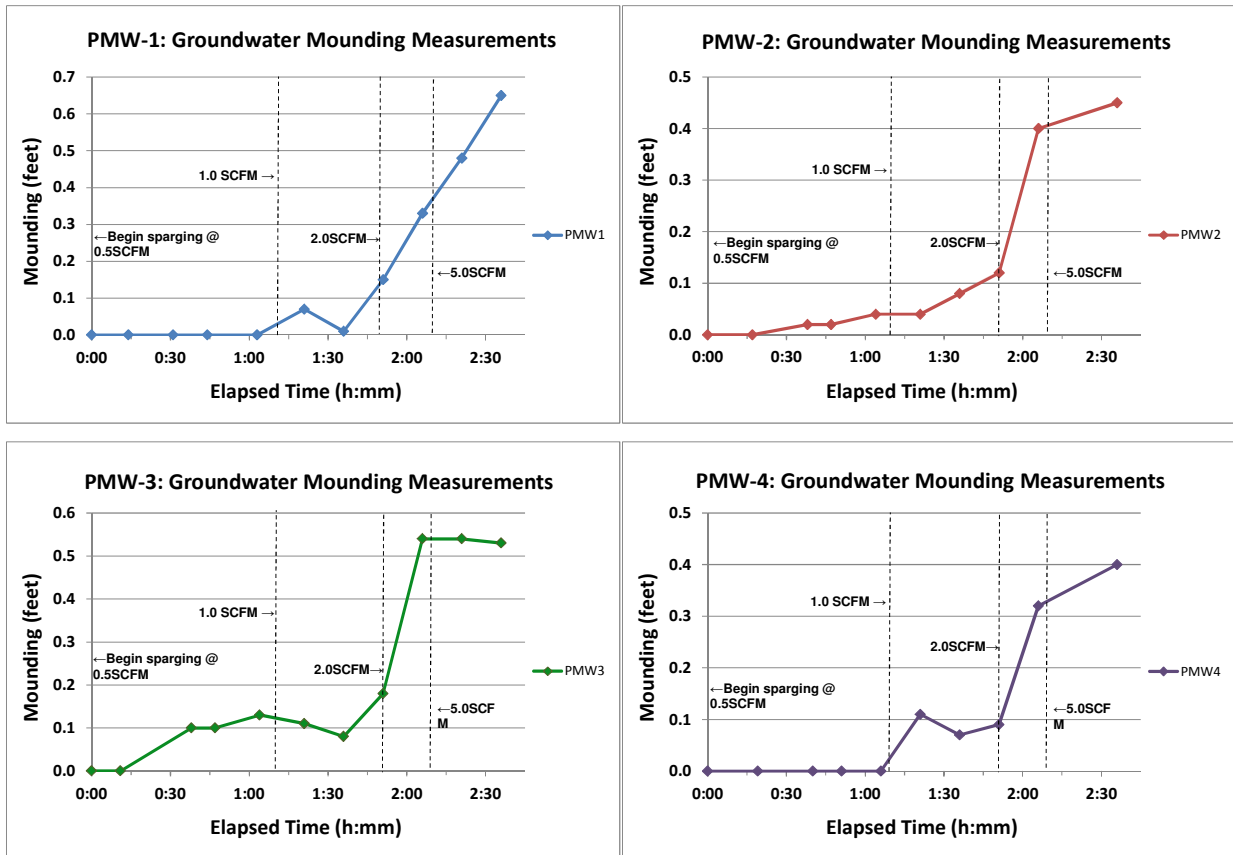
Figure 5-1. Groundwater mounding measurements in PMW-1 to PMW-4 during air sparge testing at BSW-1. The air flow rates are provided for each well and a view of the approximate well locations is provided in the bottom panel.

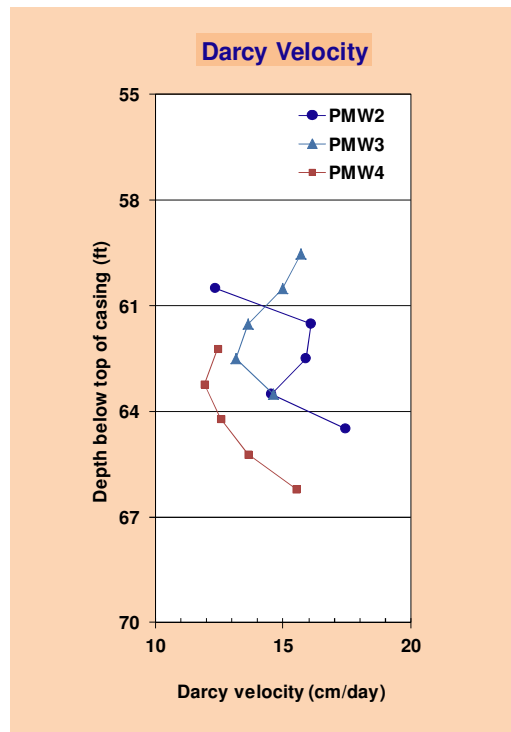
Figure 5-4. Darcy velocity in PMW-2, PMW-3, and PMW-4 based on passive flux meter testing.

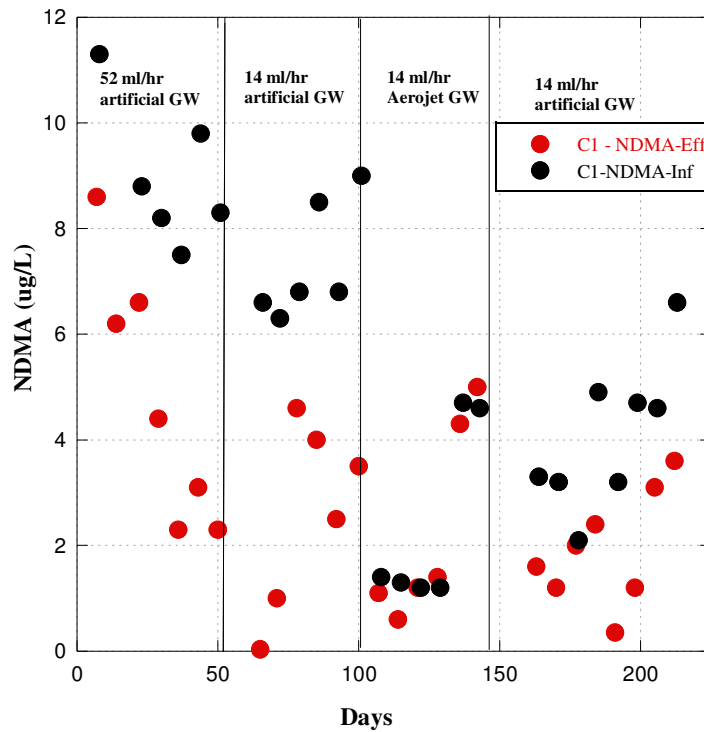
Figure 5-10. NDMA concentrations in influent and effluent water from Column 1 (C1: propane, oxygen, YE, nutrients).

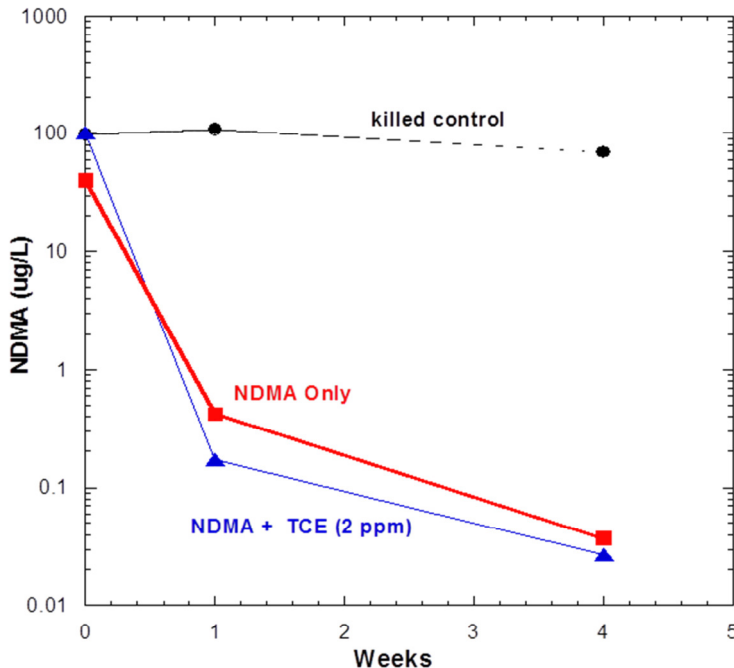
Figure 5-14. NDMA concentrations in samples from Picatinny Arsenal, NJ in the presence of absence of TCE (2 mg/L). TCE caused no difference in either the rate or extent of NDMA biodegradation, and TCE biodegraded simultaneously (from Hatzinger et al., 2008)

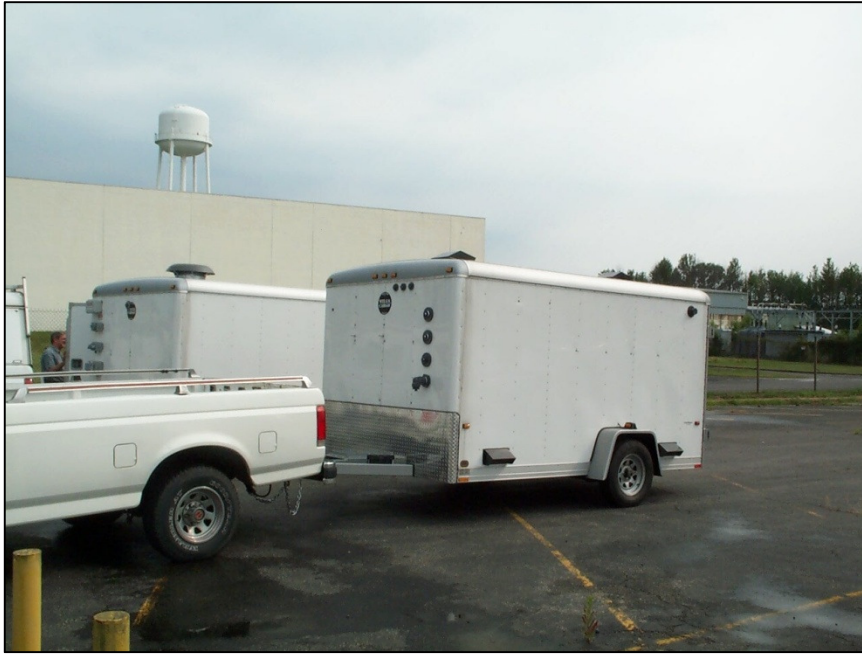
Figure 5-18. Photograph of biosparge trailer units.

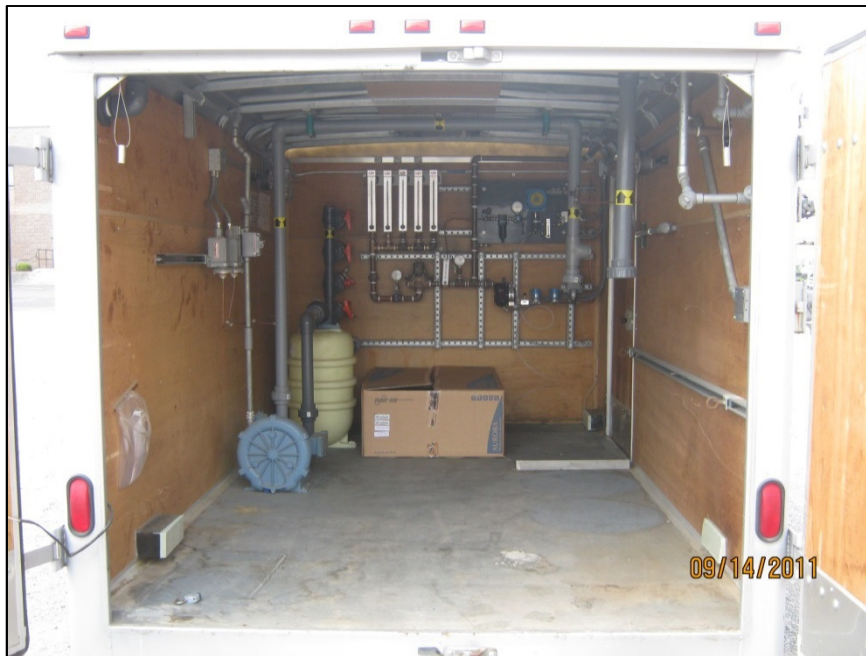
Figure 5-20. Inside of Trailer # 2, which houses the propane feed and distribution as well as SVE equipment.

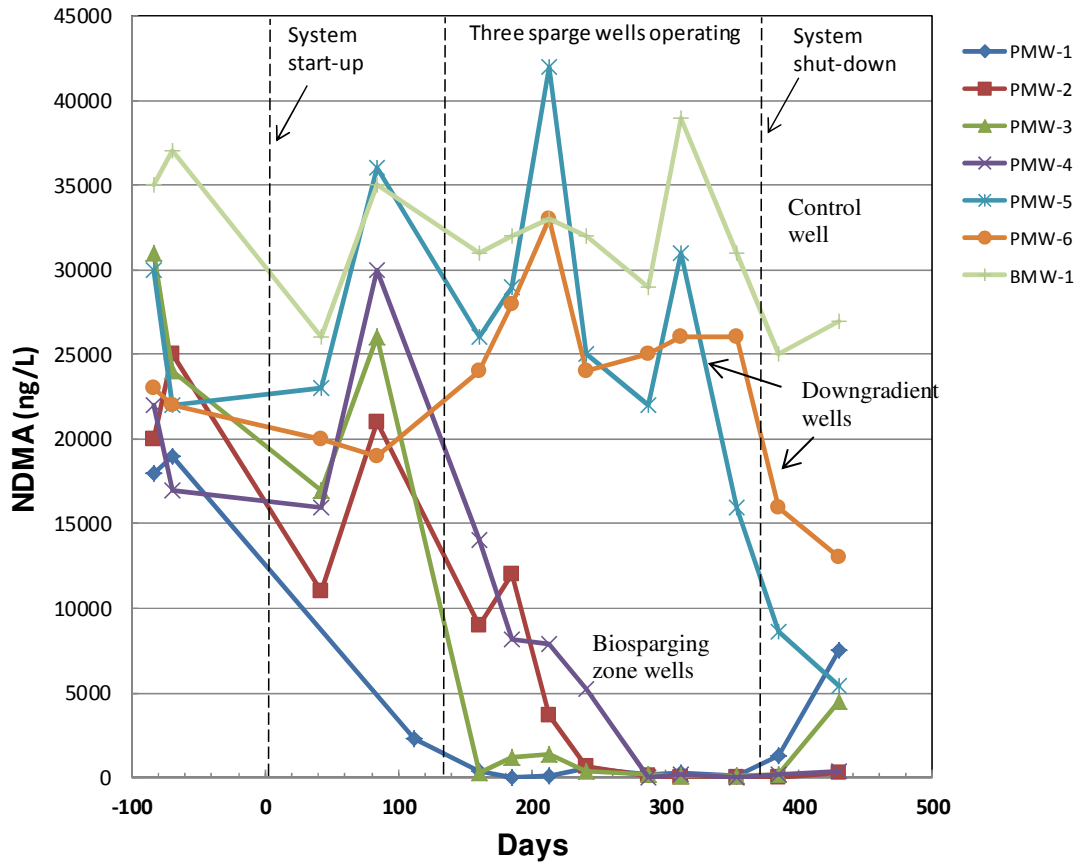
Figure 5-24. Concentrations of NDMA in the demonstration plot.

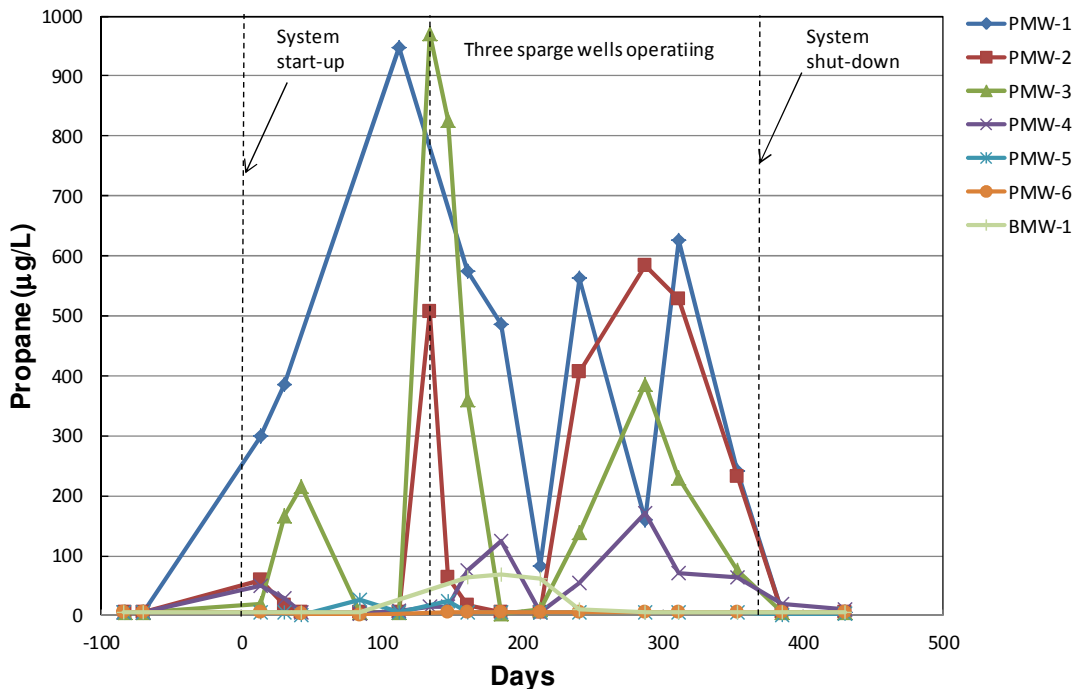
Figure 5-25. Concentrations of propane in the demonstration plot.

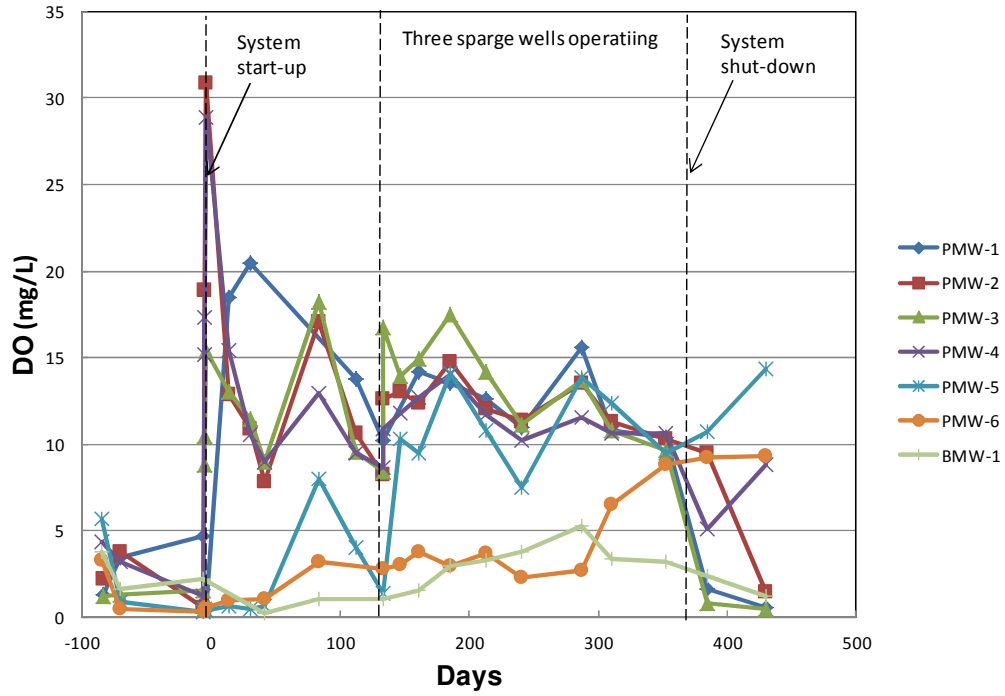
Figure 5-27. Concentrations of dissolved oxygen in the demonstration plot wells.

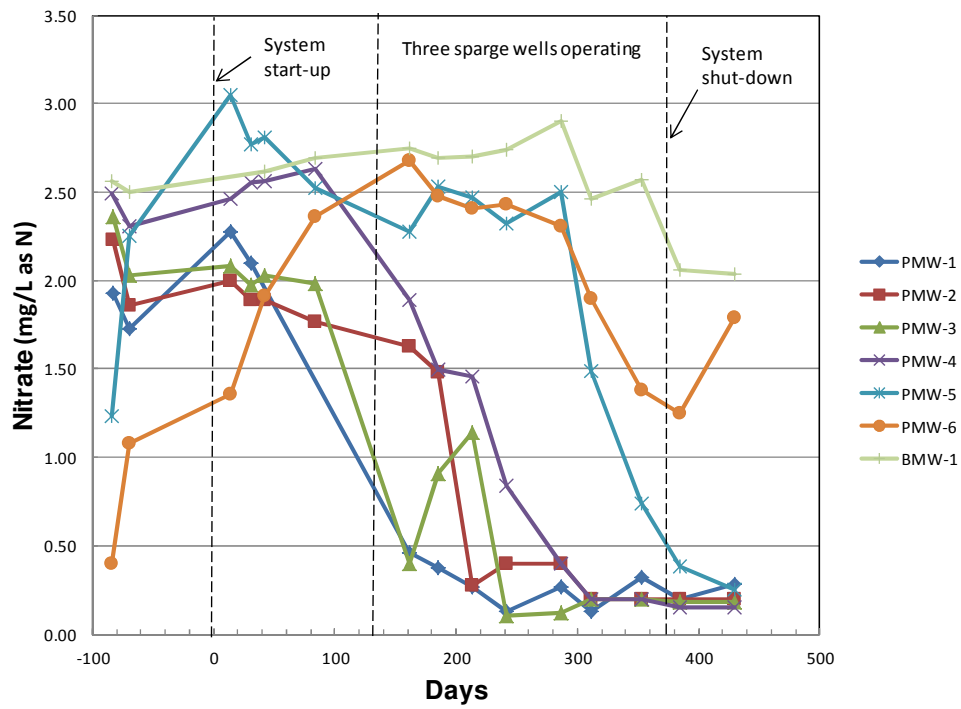
Figure 5-29. Concentration of nitrate-N in the demonstration plot wells.

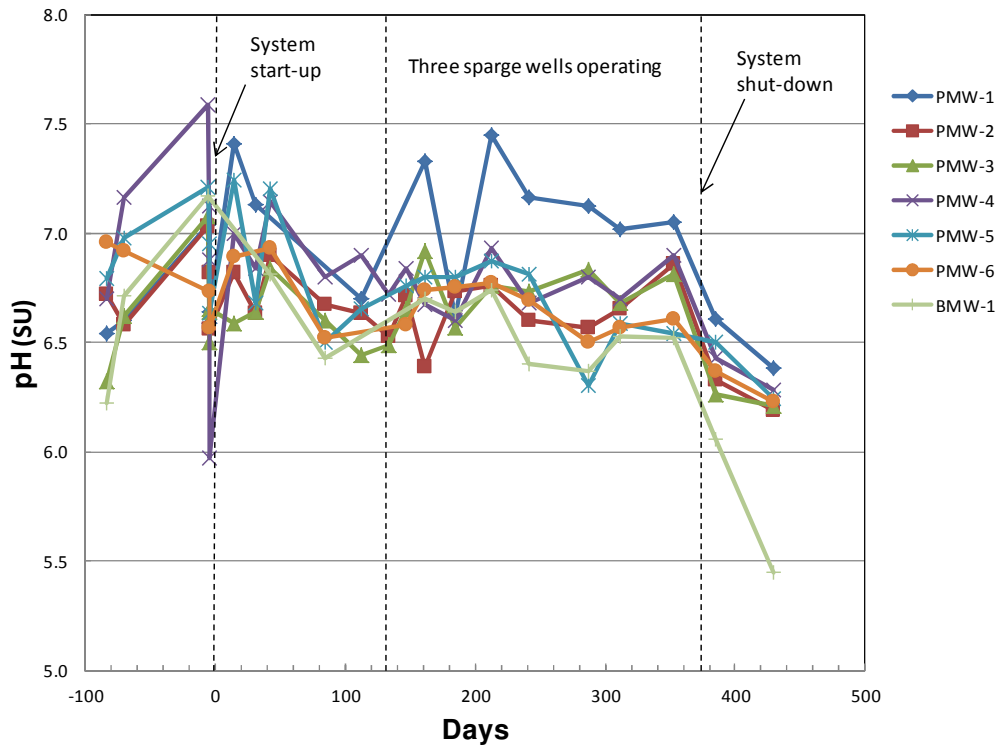
Figure 5-31. pH of groundwater in the demonstration plot wells.
